Manhole Inspection Summary

Manhole # S17GG_016MH

Insp Date: **10/31/07 10:08 AM**

Location Address: **REAR 1610 WARWICK**

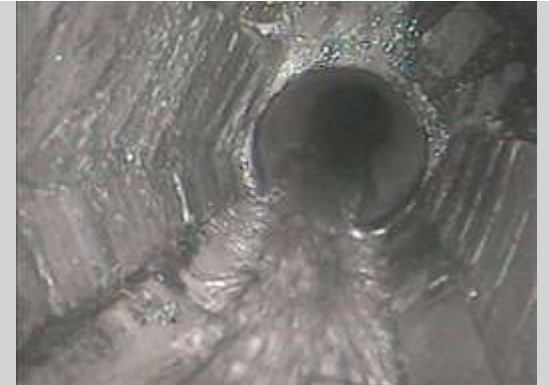
12 O'Clock Outflow

8 in. Circular Gravity Sewer
Pipe Out @ 12 O'Clock

Pipe Material: **Clay** ☐ Pipe Lined

Invert Depth: **8.92** (ft.) Flow Characteristics: **Slow**

Deposits: ☒ None ☐ Mud ☐ Sludge ☐ Debris ☐ Grease

Infiltration: **None** Pipe Seal Cond: **Sound**

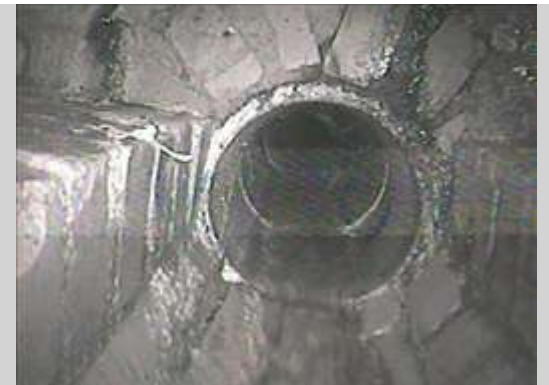
6 O'Clock Inflow

8 in. Circular Gravity Sewer
Pipe In @ 6 O'Clock

Pipe Material: **Clay** ☐ Pipe Lined

Invert Depth: **8.80** (ft.) Flow Characteristics: **Slow**

Deposits: ☒ None ☐ Mud ☐ Sludge ☐ Debris ☐ Grease

Infiltration: **None** Pipe Seal Cond: **Sound**
